國立聯合大學第十宿舍

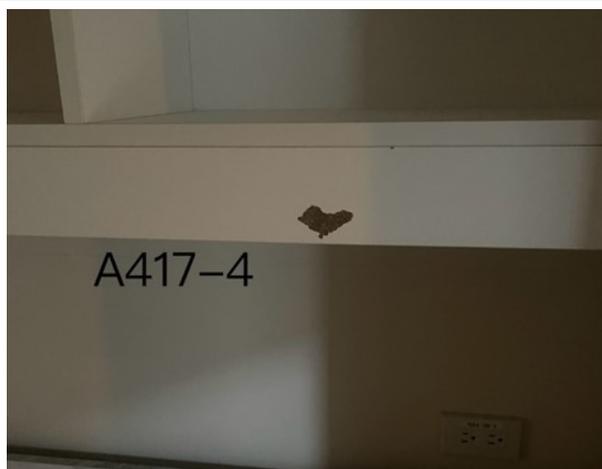
4樓 A417-4 書桌貼皮破損

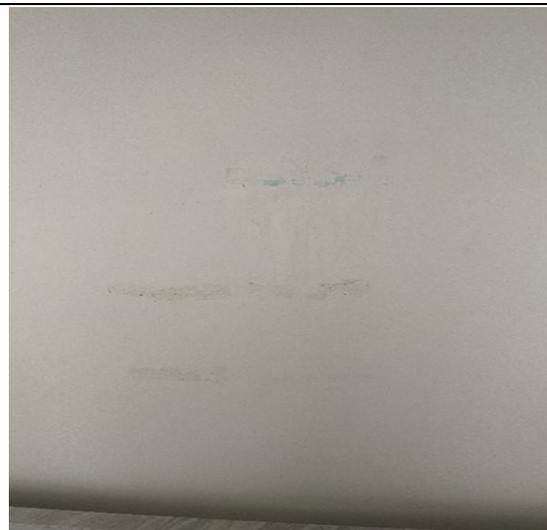
2樓 A213-3 牆壁殘膠

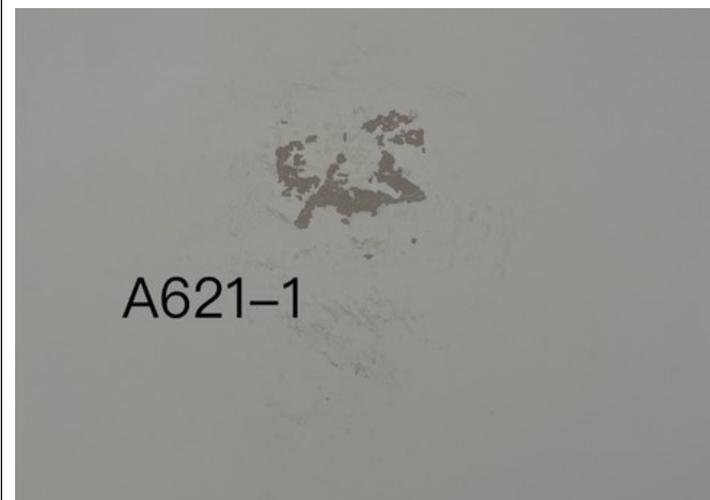
6樓 A621-1 牆壁油漆剝落

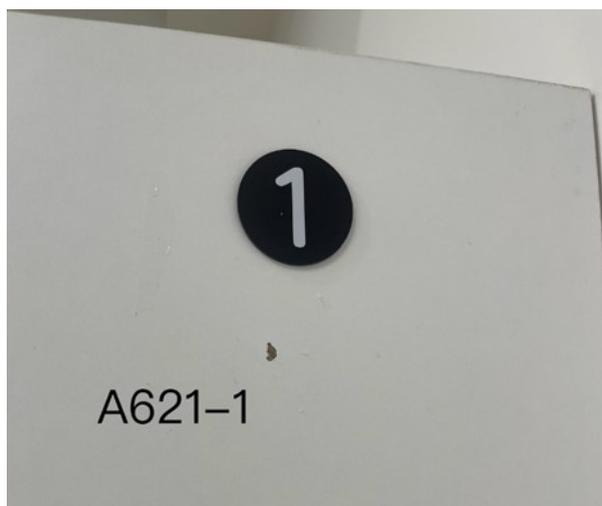
6樓 A621-1 書桌貼皮破損

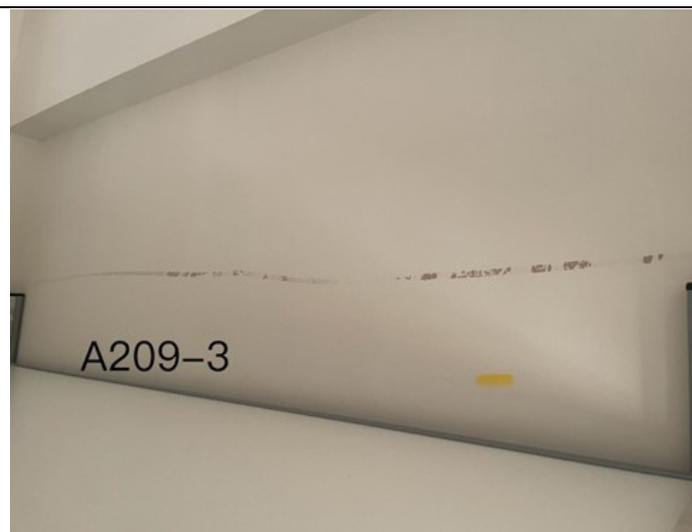
2樓 A209-3 床旁邊牆壁油漆剝落

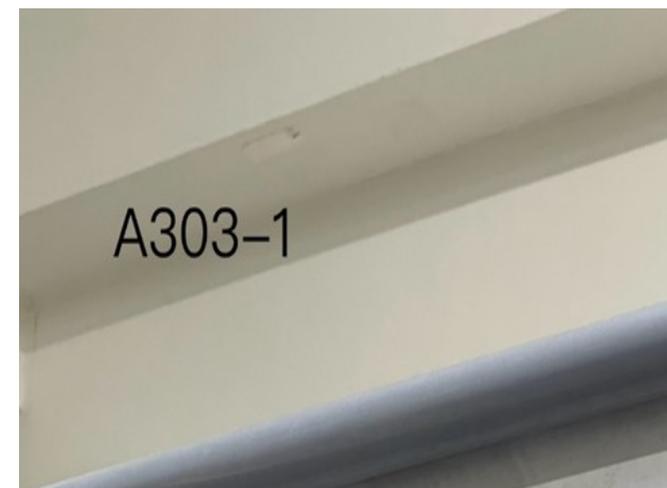
3樓 A303-1 牆壁殘膠

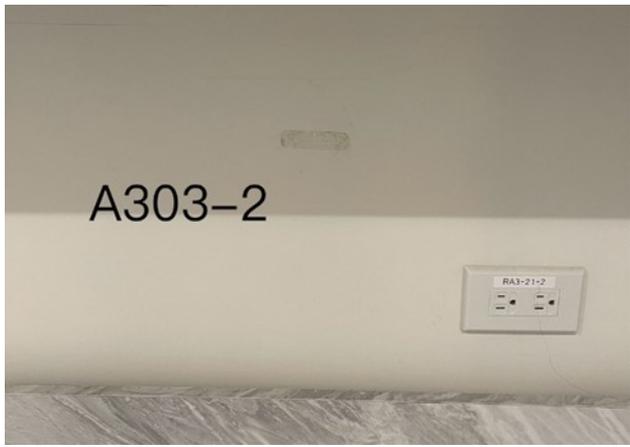
<p>A303-2</p>

<p>A303-4</p>
<p>3樓 A303-2 牆壁殘膠</p>	<p>3樓 A303-3 牆壁殘膠</p>	<p>3樓 A303-4 牆壁殘膠</p>

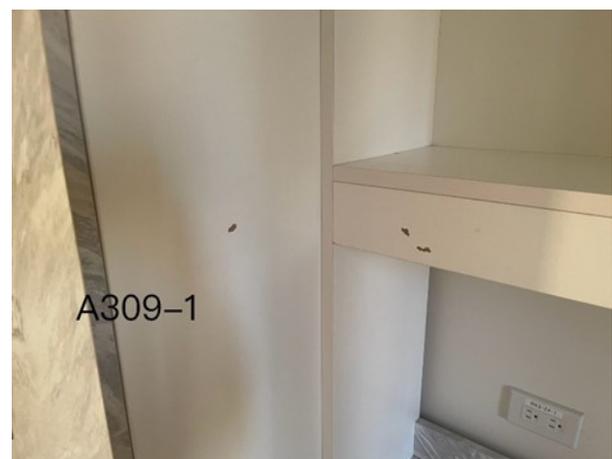
<p>A309-1</p>

<p>A605-1</p>
<p>3樓 A309-1 掛鈎痕</p>	<p>5樓 A503-3 牆壁殘膠</p>	<p>6樓 A605-1 牆壁、殘膠、掛鈎</p>

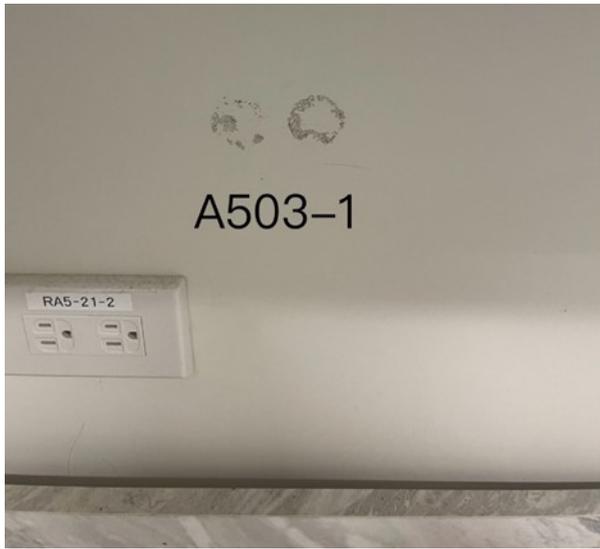
5樓 A503-1 牆壁殘膠

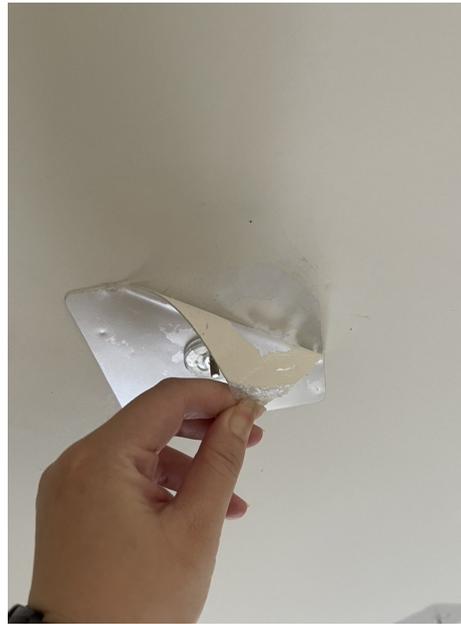
2樓 A204-2 牆壁掉漆、殘膠、掛勾

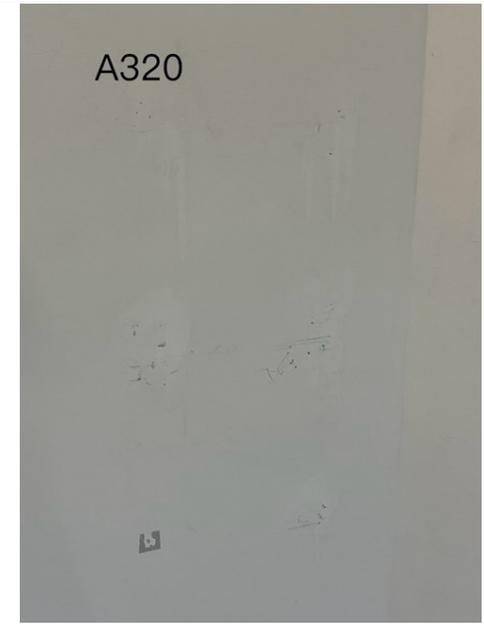
3樓 A320 公共區域牆壁油漆剝落

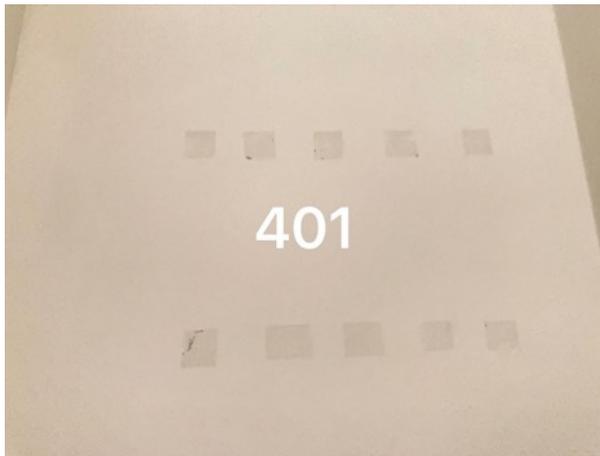
4樓 A401 公共區域
